**IYC – St. Charles**  
**September 14, 2009**  
**John Howard Association of Illinois Site Visit**

**Summary**

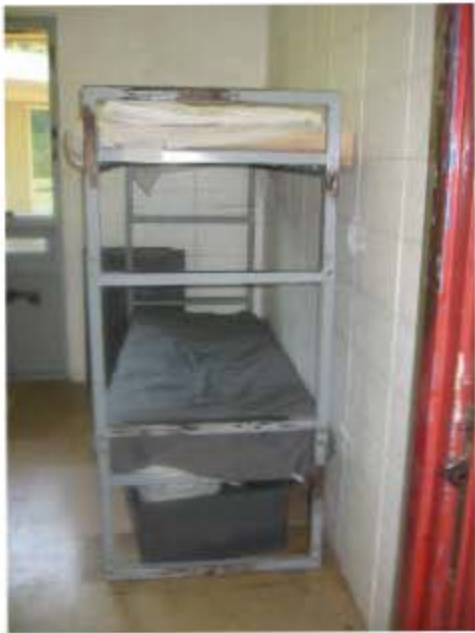
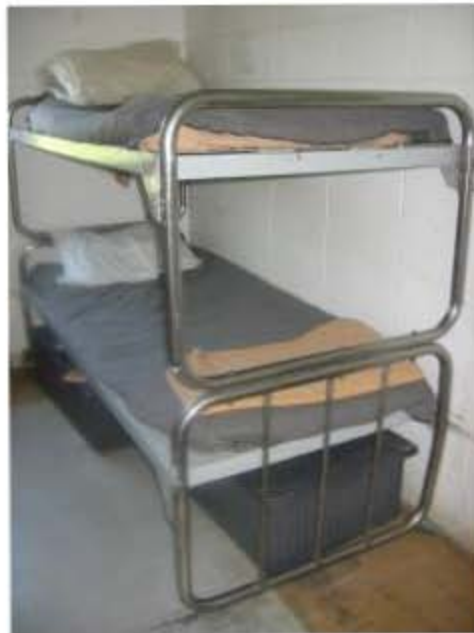
The vast majority of the rooms are configured to house two youth and those rooms almost always are equipped with bunk beds. These metal frame beds (typically bolted to the floor) provide the easiest, most apparent opportunity for suicide by providing a strong, stable base from which a piece of cloth or cord can be suspended. Even those rooms without bunk beds almost always have metal frame beds that are sufficiently high off the ground that they could be used as a hanging post.

Bunk Beds

- Eliminate the practice of double bunking and the use of bunk beds, and replace all beds with the type that is a solid piece with no legs or protrusions from which to tie off and bolt them to the floor. (Norix makes such a bed called the “Attenda floor mount bed.”)

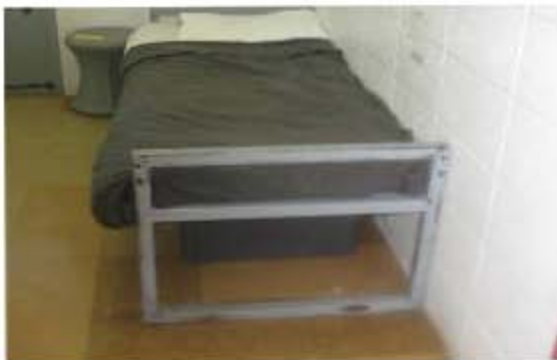
Single Bed

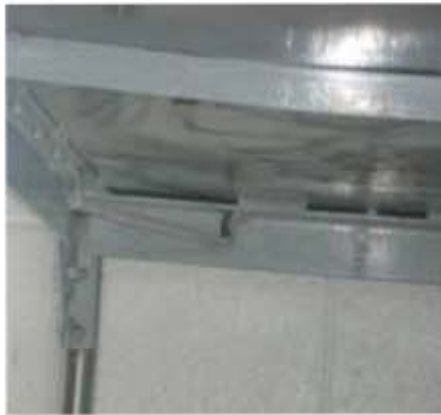
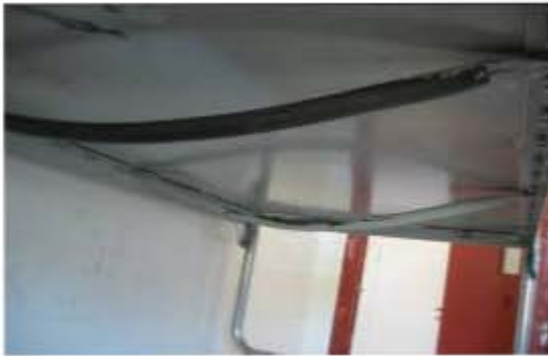
In addition, many beds have dangerous protrusions that offer additional opportunities for self harm.

Dangerous Protrusions

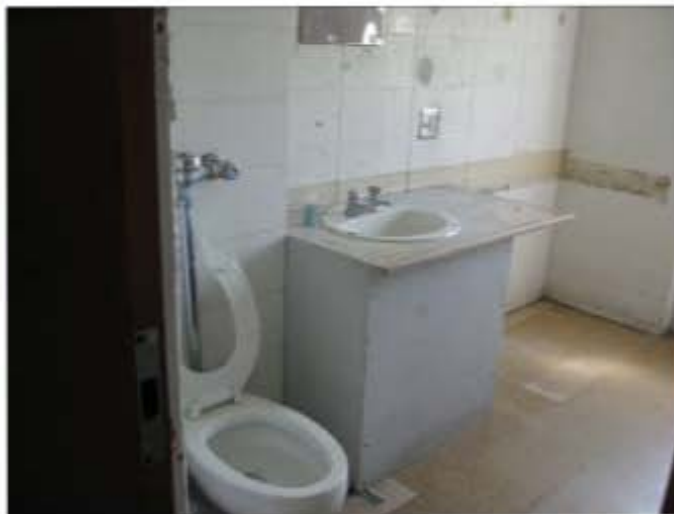
Less than half of the living units have sleeping rooms equipped with the more suicide proof metal toilet/sink units that have no exposed pipes or faucets. The other rooms have porcelain toilets and sinks with exposed pipes, and faucets from which a youth can tie off. Many even have removable toilet seats which pose an additional danger as a potential weapon. Most of the rooms with the porcelain toilets and sinks are constructed with a wooden partition that partially surrounds the sink and separates the toilet area from the sink. These partitions are old and many contain holes that present an additional location from which a youth can tie off.

Unsafe Porcelain Toilet and Sink

- Replace the porcelain sinks and toilets with the steel toilet/sink units.
- Replace the vent covers with a break away plastic cover or insure that there are no items in the sleeping rooms that youth can use to climb to reach the covers. (This would involve bolting beds and stools and discarding the property boxes.)

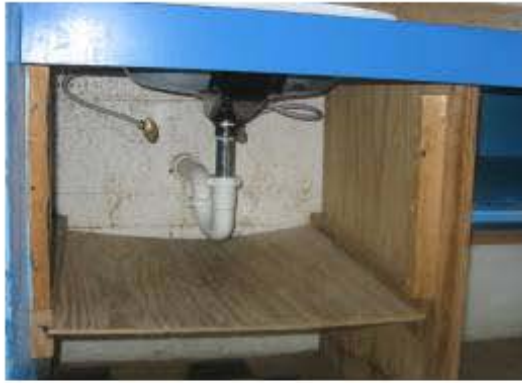
Exposed Unsafe Sink Pipes

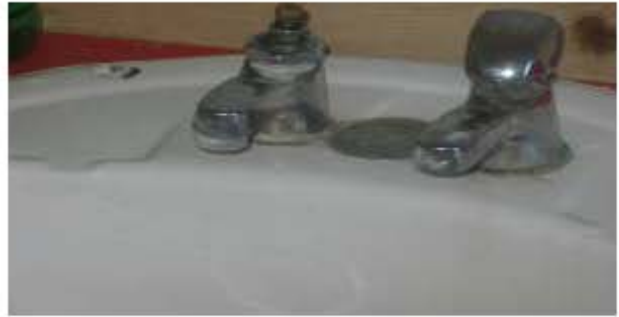
Unsafe Sink Faucets

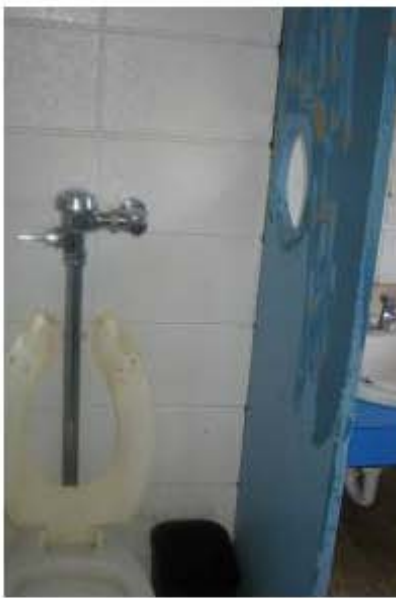
Porcelain Toilet with Partition

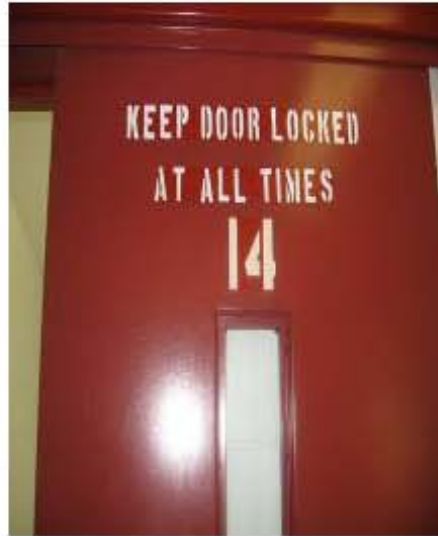
Entry to each sleeping room is through a heavy metal door kept closed and locked during much of the day. The view into the room is through a narrow glass window (approximately 4X15 inches) at eye level. Because of the placement of the window and the room's furnishings it is not possible to view residents who are inside without being immediately adjacent to the door.

Sleeping Room Door with Limited View

- Increase the ratio of staff to kids to 1 to 8 during the waking hours and 1 to 24 during the night. In lieu of increases in staff, and ideally as an additional safe-guard, install two way auditory devices in all sleeping rooms and cameras in some.

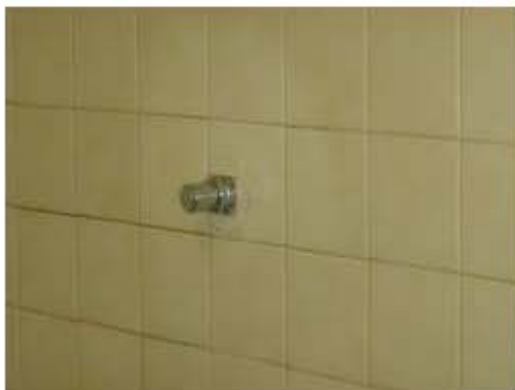
Each wing of a cottage has a communal shower room. These rooms have minimal furnishings: a few shower heads, perhaps a soap dish and a few hooks from which to hang a towel. State of the art correctional design and architecture has produced items which will serve these purposes without providing an opportunity for self-harm. Shower heads can be constructed of a short sloped piece of metal and hooks can be used which will break off or collapse if significant weight is exerted on them. Soap dishes can be recessed. In most instances the shower rooms at St. Charles have not employed these devices, or in the case of the hooks, the devices are old and seem to have solidified in place and can now support significant weight.

Unsafe Shower Control

- Replace all shower heads, soap dishes and hooks in the shower rooms which pose a risk for self-harm.
- Repair all broken and leaking plumbing in the sleeping rooms and shower rooms. Remove mildew and mold as needed.

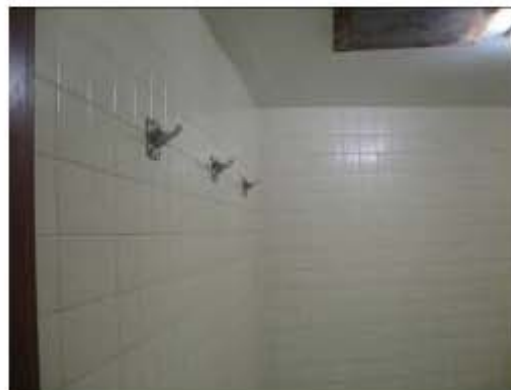
Unsafe Rigid Shower Hooks

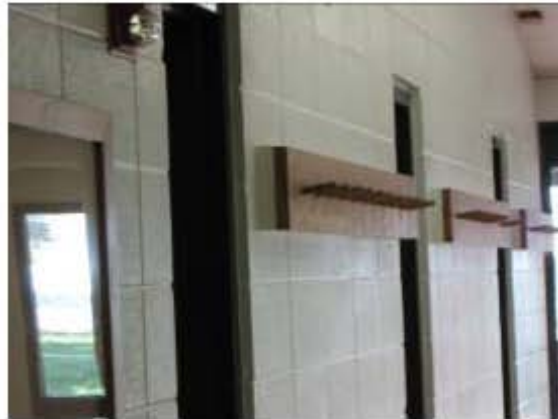
In general, common areas (day rooms and corridors) are themselves free of significant opportunities for self-harm particularly when coupled with more observation of staff. But even here there can be problems such as hooks used for hanging outerwear particularly with poor sight lines, the existence of partitions to separate areas and staff that spend time in enclosed offices.

Unsafe Coat Hooks in Dayroom

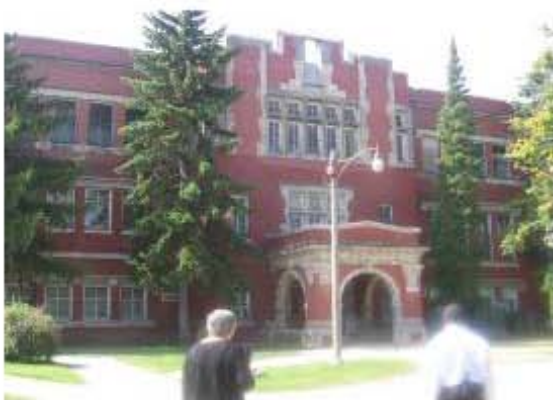
These problems did not occur overnight and are a result of trying to maintain an aging facility with decades of deferred maintenance and quick/cheap fixes to serious problems. One obvious example is the academic building/chapel that is now abandoned due to water damage, mold and mildew. The unfortunate consequence is that youth can no longer worship in the handsome sanctuary which boasts an original mural by world renowned Chicago artist Warner Sallman on the wall behind the altar.

Exterior of Academic Building/Chapel

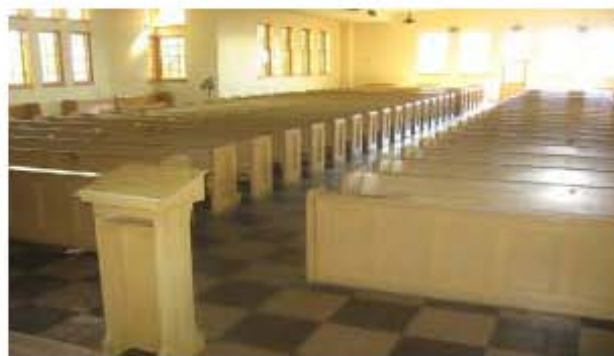
Interior of Sanctuary

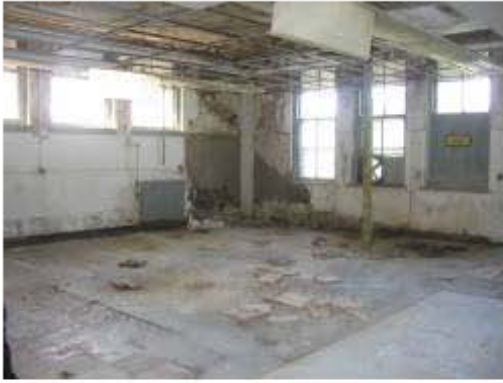
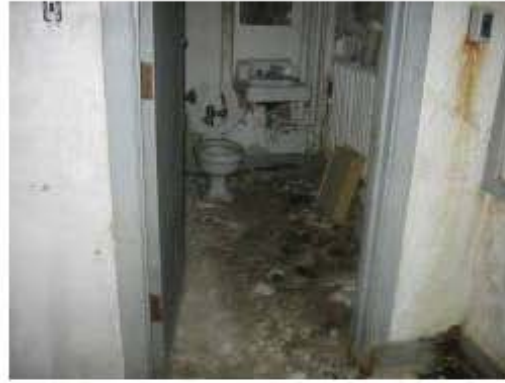
First Floor of the Academic Building Formerly the Wood Shop

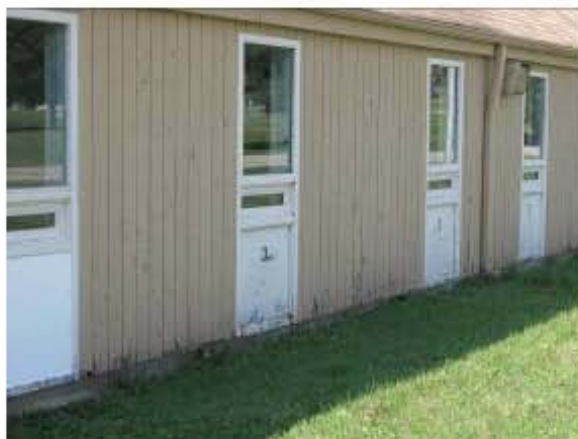
The ten housing units resemble one another in both appearance and construction. They are one story structures constructed economically in the seventies using cinder block coated with wood planking on the exterior set on concrete slabs; unbreakable glass windows which cannot be opened are set in metal frames. Floors in the building are covered with tile. Over the years the tiles have worn and many are cracked or missing. Because the mastic used to affix the tiles to the floor contained asbestos the cost of properly remediating the asbestos and replacing the tiles is high and many floors have not been fixed. The buildings have the original individual heating and air conditioning units; they are energy inefficient and have frequent breakdowns. The downspouts of these buildings were at one time connected to an underground drainage system but have since been disconnected. The result is water damage to some of the cottages which degrades the wood paneling/paint and some pooling of water and creation of muddy areas outside others.

Exterior of Williams Cottage

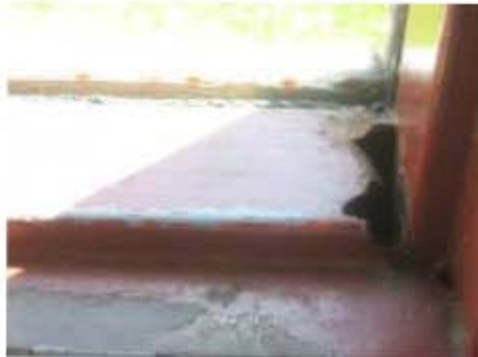
Most roofs on these buildings show their age with loose shingles and some bowing on a few. Window frames in the housing units are likewise degraded with many showing rusting and pitting.

Metal Window Frame

- Repair holes in walls, floors, and window sills.

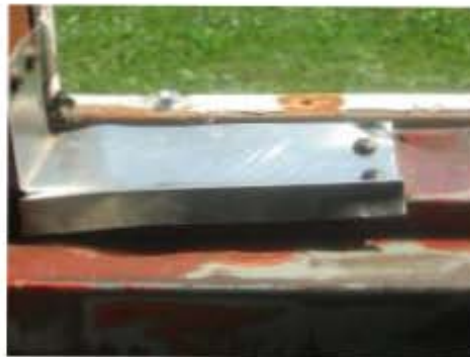
“Repaired” Metal Window Frame

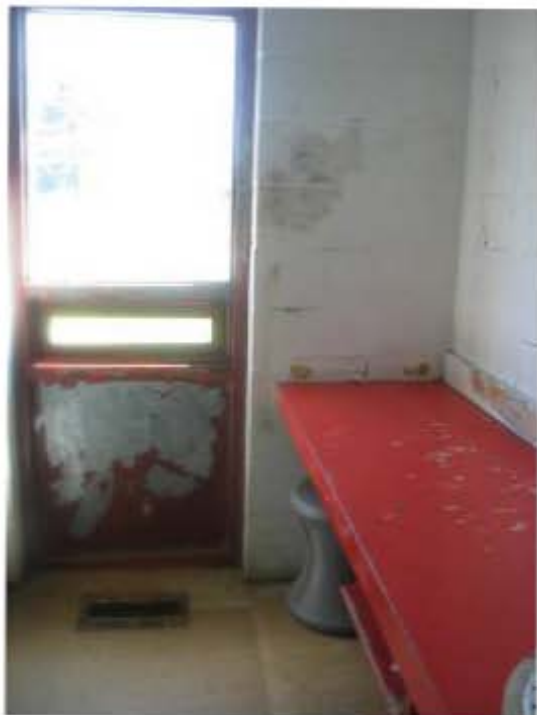
The combination of moisture and inconsistent heating and cooling has caused the deterioration of the material directly below many of the windows. In some rooms metal plates have been used to fill the spaces. Last December two youth escaped through such a space where they had loosened the screws holding the plate.

Sleeping Room with Metal Plate

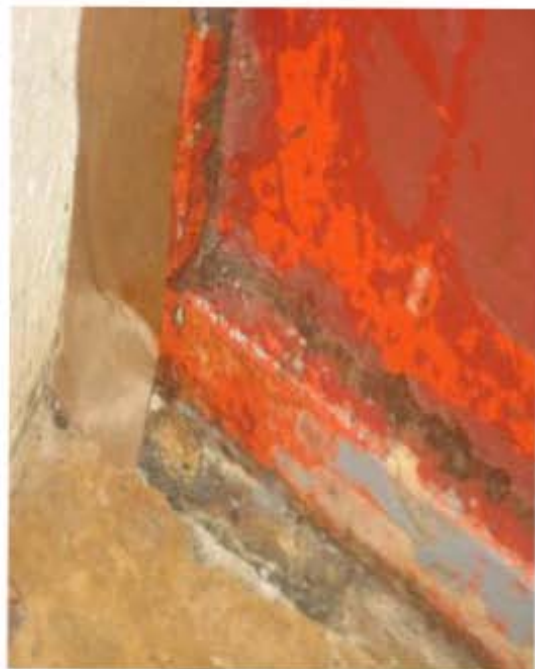
Close-up of Metal Plate
