**IYC – St. Charles**  
**September 14, 2009**  
**John Howard Association of Illinois Site Visit**

**Summary**

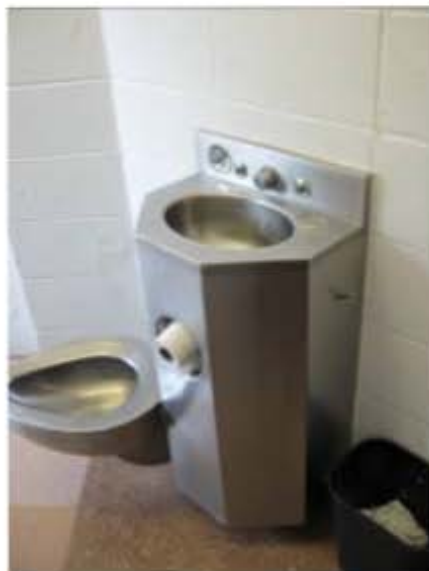
Metal Toilet/Sink Unit

Less than half of the living units have sleeping rooms equipped with the more suicide proof metal toilet/sink units that have no exposed pipes or faucets. The other rooms have porcelain toilets and sinks with exposed pipes, and faucets from which a youth can tie off. Many even have removable toilet seats which pose an additional danger as a potential weapon. Most of the rooms with the porcelain toilets and sinks are constructed with a wooden partition that partially surrounds the sink and separates the toilet area from the sink. These partitions are old and many contain holes that present an additional location from which a youth can tie off.
